# Dynamic investigation on the Mirandola bell tower in post-earthquake scenarios

**Abstract** After the seismic events of the 20th and 29th of May 2012 in Emilia (Italy), most of the monumental and historic buildings of the area were severely damaged. In a few structures, partial collapse mechanisms were observed (e.g. façade tilting, out-of-plane overturning of panels...). This paper presents the case-study of the bell tower of the Santa Maria Maggiore cathedral, located in Mirandola (Italy). The dynamic response of the structure was evaluated through operational modal analysis using ambient vibrations, a consolidated non-destructive procedure that estimates the dynamic parameters of the bell-tower. The dynamic tests were carried out in pre-intervention and post-intervention conditions in order to understand the sensitivity of dynamic measurements to safety interventions. Furthermore, a comparative study is made with similar cases of undamaged masonry towers up to the 6th mode. Finally, an investigation on the state of connections and of the building itself is carried out via FE model updating.

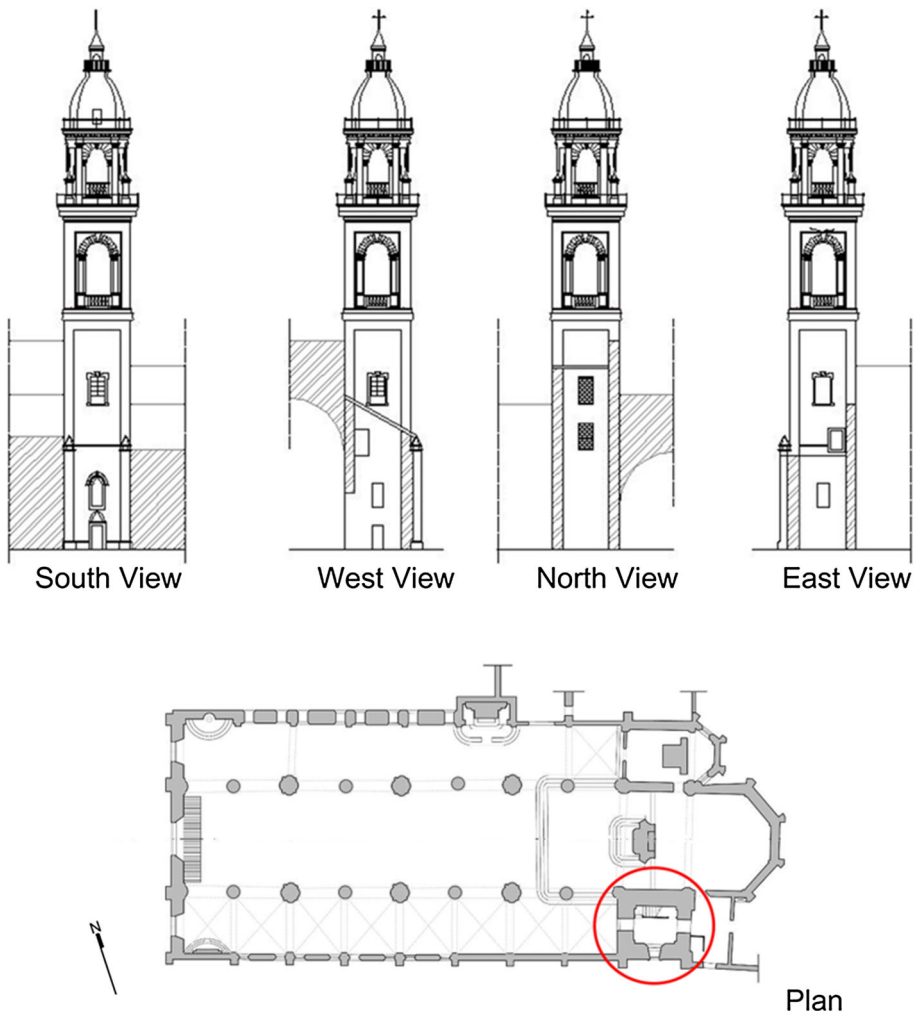
The construction of the bell-tower of S. Maria Maggiore cathedral in Mirandola (Modena, Italy) (Fig. 1) started in the late fourteenth century. The bell-tower, made of brick masonry, is located on the south-east side of the cathedral. It is square in plan with dimension of 5.90 m and has a current height of 48 m. The building, like the whole cathedral, is the result of several alterations which occurred over the centuries. The most relevant modifications were made in the seventeenth century when the height of the original tower was tripled (Ceretti 1889) and the structure was reinforced and partially rebuilt to withstand the new loads. Another important alteration dates back to the eighteenth century, when the bell-tower was completed with an octagonal stone roofing.

The bell tower has two orders of large openings close to the top, unusually the larger ones are at the lower level (21 m) and the top ones at the belfry level (30.5 m). In the

**Fig. 1** Main fronts of the bell-tower and plan

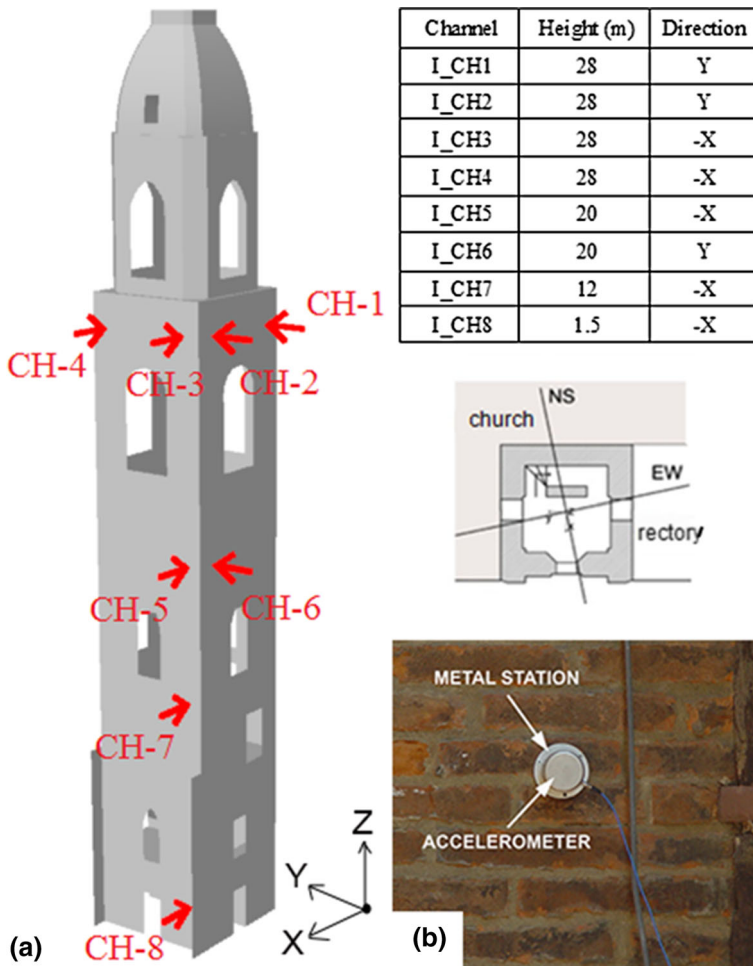
The accelerometers were installed by means of special metal bases fixed directly on the wall with expansion anchors (Fig. 6b). The metal bases were left in place to simplify the execution of more tests to assess further damage and the long-term effectiveness of the

**Fig. 6** **a** Instrumentation setup, location and orientation of accelerometers. **b** Detail of the installation of the accelerometer on the bell-tower

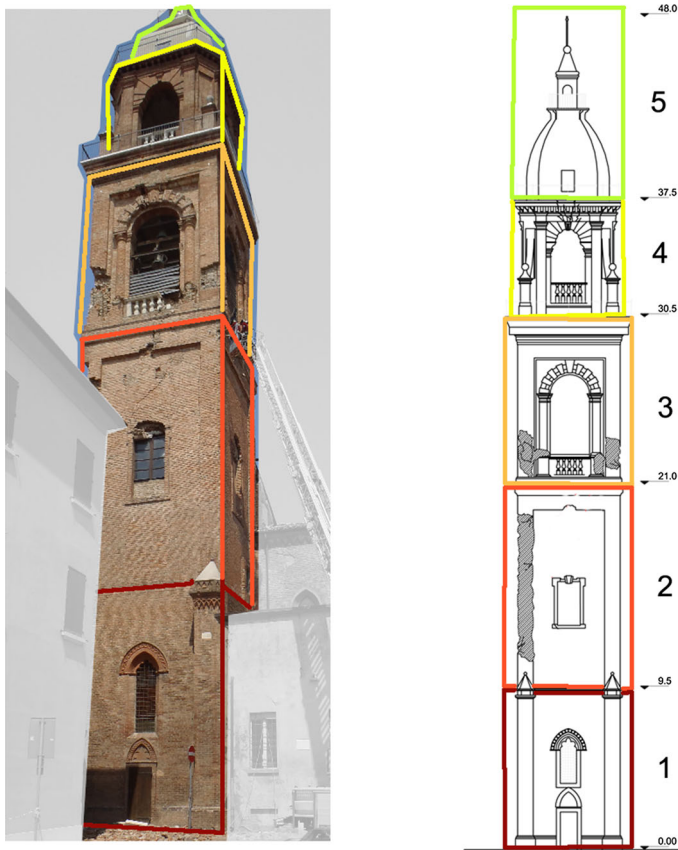
The initial properties of the masonry were assumed from the literature (Fernandes et al. 2010) and from the current Italian code (i.e. Young modulus: 1.5 GPa, Poisson's ratio: 0.4, density:  $1900 \text{ kg/m}^3$ ). A second type of material (Young modulus: 1.5 GPa, Poisson's ratio: 0.4, density:  $1700 \text{ kg/m}^3$ ) was attributed to the shell elements of the stone dome. In the baseline FE model, a thickness of 1.15 m was set for the two first levels according to the available data, whilst thickness of 0.55 and 0.35 m were assigned to the other two sub-part levels according to the visual inspection.

**Fig. 10** The five sub-parts of the bell-tower

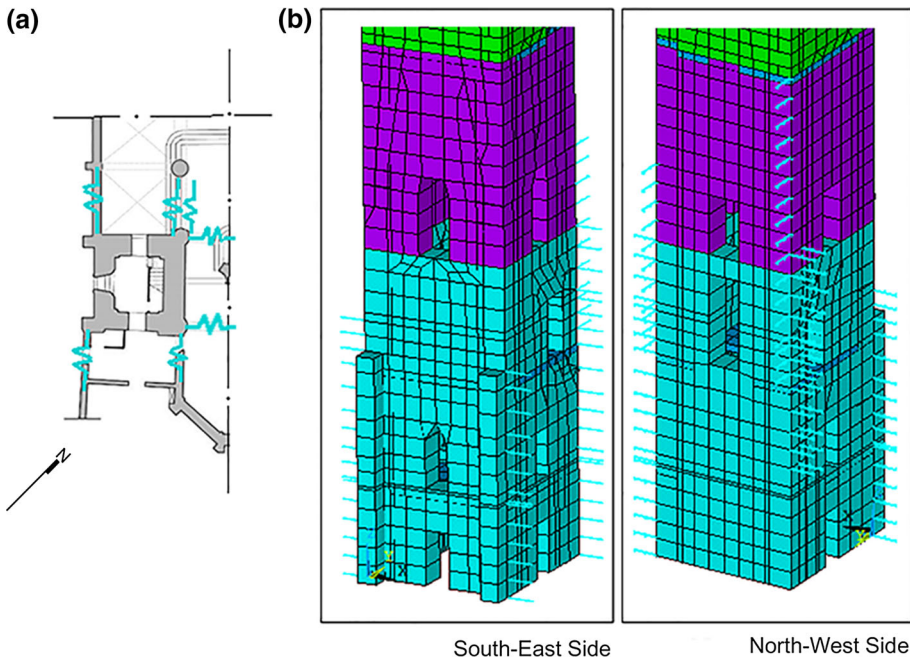
For the boundary conditions of the tower, and specifically its interactions with the adjacent buildings (i.e. the Cathedral of Santa Maria Maggiore and the rectory), linear spring elements were used on each side (East, West and North) in correspondence to the rectory wall, the apse arches and the nave walls, as it is possible to notice in Fig. 11. In the

**Fig. 11** **a** Idealisation of spring elements as boundary conditions due to nearby buildings. **b** Localization of the 3D-linear spring elements on the FE model

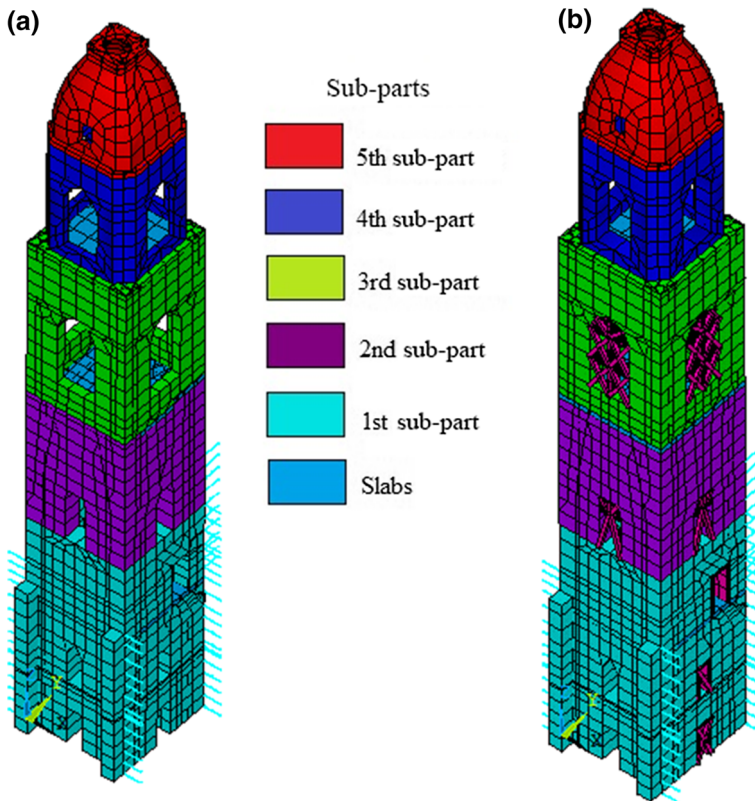
In a second phase, the safety interventions were added to the FE model (Fig. 12b). The interventions were modelled resorting to beam and truss type finite elements idealising the wooden falsework installed in the openings of the bell-tower at the different levels (Fig. 5). The material properties (Young modulus: 8 GPa, Shear Modulus: 0.5 GPa, density 370 kg/m<sup>3</sup>) assigned to these elements were chosen according to the Italian Fire Department's manual for safety wooden interventions (Ministero dell'Interno and Corpo Nazionale dei Vigili del Fuoco 2011). The metal tie-rods were not modelled with specific finite elements, but the effect of their presence is evaluated indirectly during the model updating phase by the variation of the mechanical properties. If the intervention is effective, the metal tie-rods

**Fig. 12** Baseline FE model of the bell-tower subdivided in sub-parts (a), FE model with safety interventions (b)

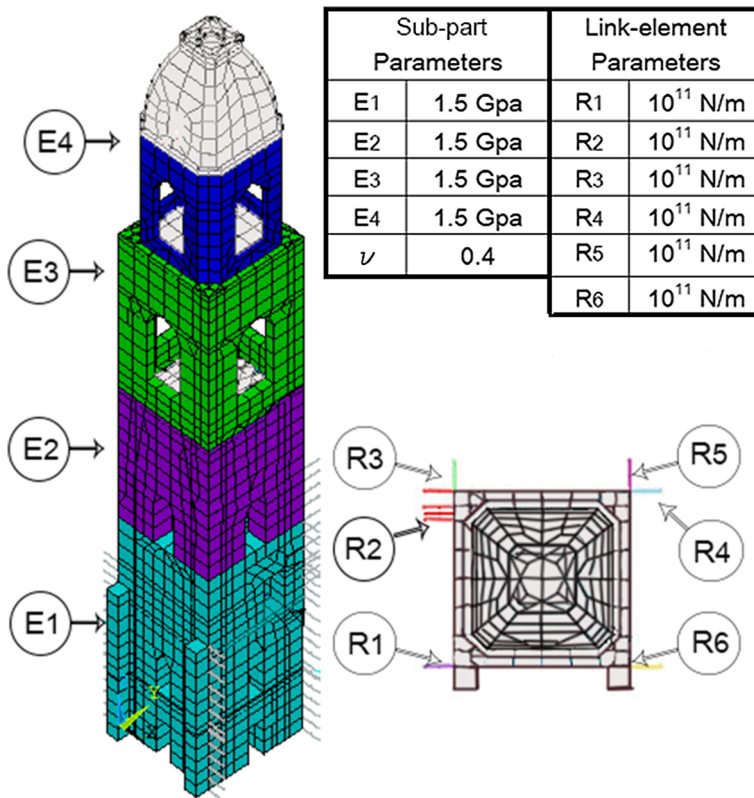
**Fig. 13** Finite element model discretization associated to the chosen updating parameters and related initial values

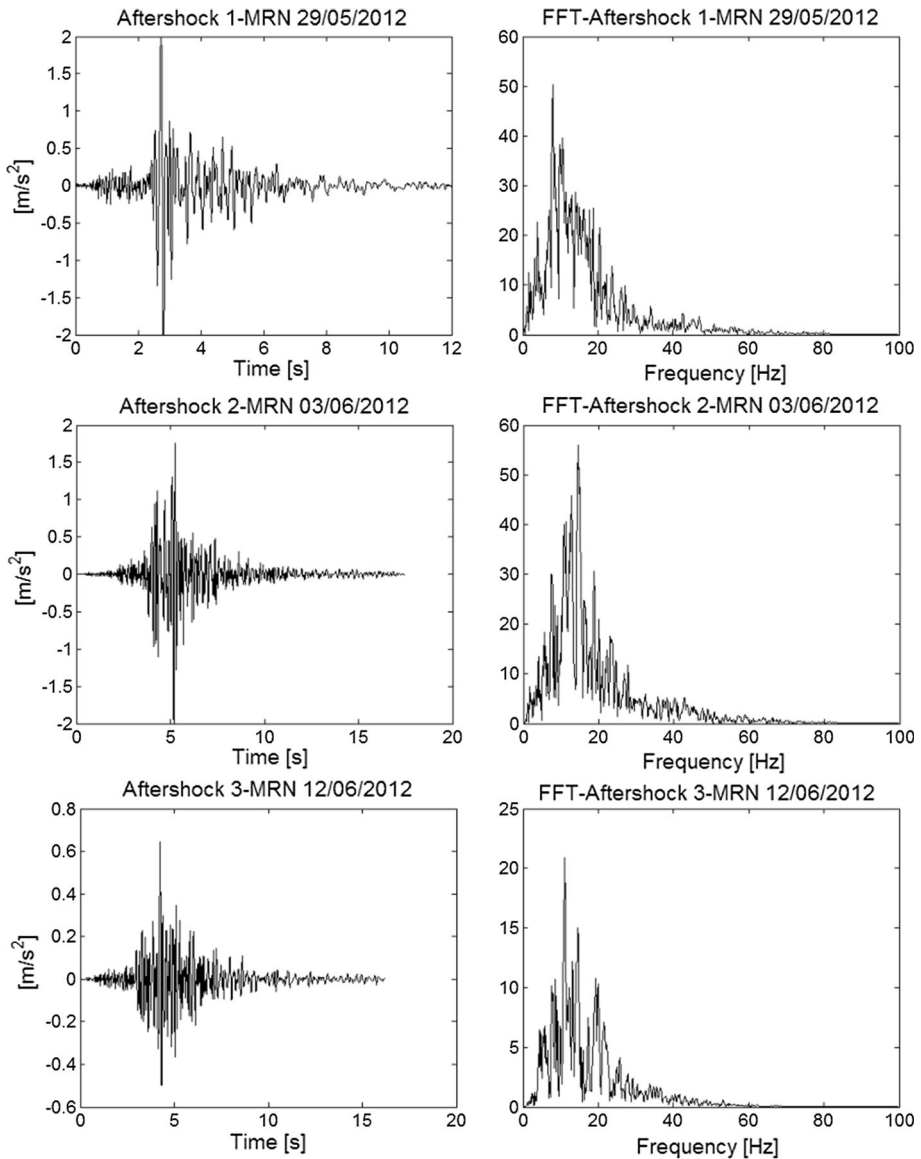
Figure 15 shows the aftershock accelerograms used as input for the dynamic analysis and their frequency content. For brevity's sake, only the accelerograms referring to the main direction of the earthquake are reported (which are respectively N–S for the first two and E–W for the third one) but a three component excitation has been applied to the FE model.

**Fig. 15** Acceleration and frequency response spectra of the three aftershocks related to the respective main direction

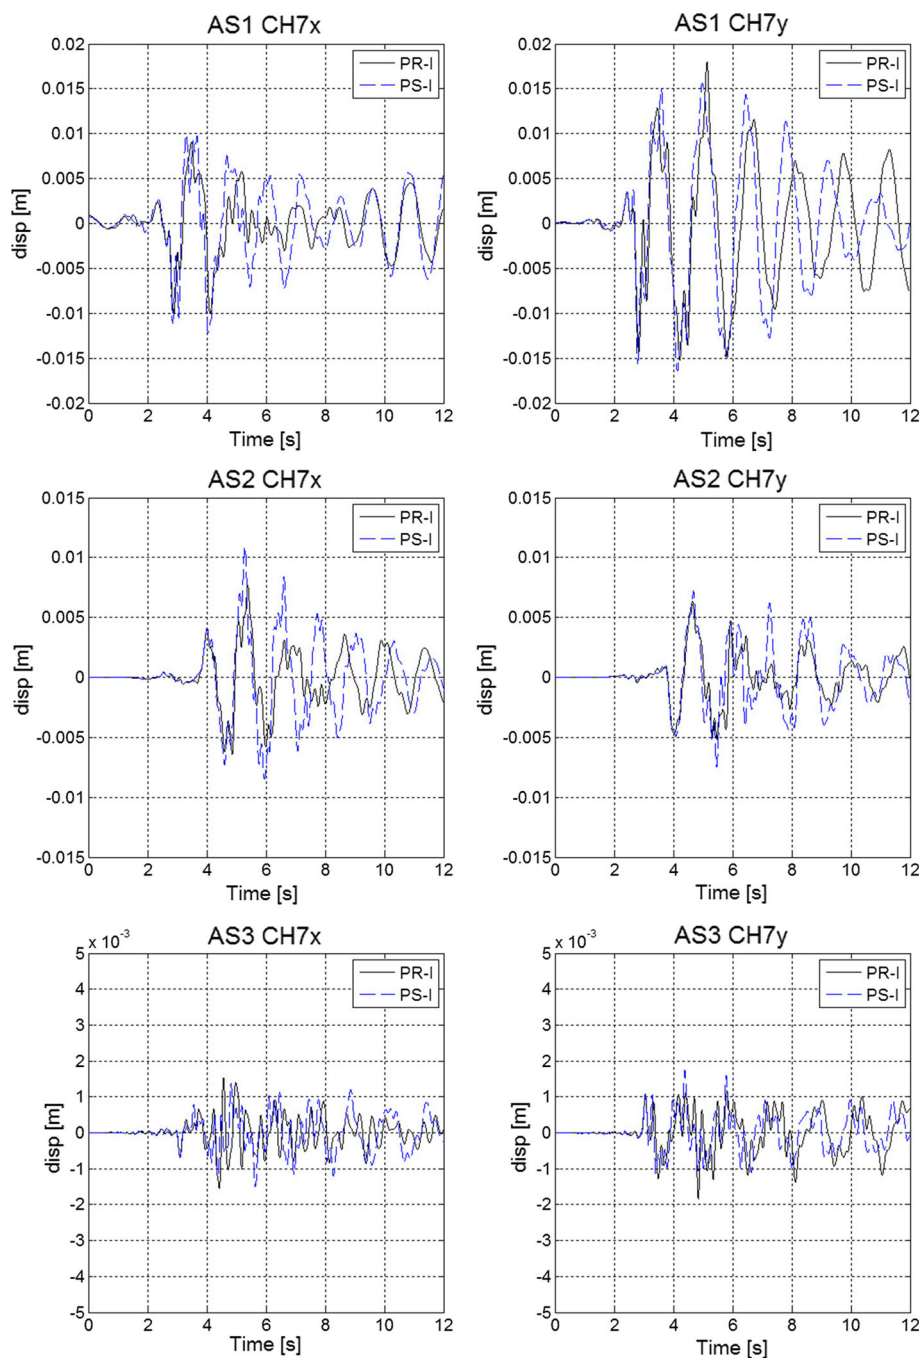
**Fig. 16** Comparison between the displacement responses related to CH7-position (direction  $x$ —first column, direction  $y$ —second column) in the pre (red line) and post (blue line) condition

Finally, the results of two points (roughly corresponding to CH-3 and CH-7 in Fig. 6) carefully chosen in the structure, respectively at 12 and 28 m of height were used as a benchmark of comparison for the PR-I and PS-I configurations. Both points should be affected by the false works at the openings and the safety interventions, and the updating results seemed to confirm this effect, because the elastic modulus in correspondence of the 2nd and 3rd sub-part showed a sensible variation.

The maximum displacements values are obtained for the CH-7 position, located in a higher, thus more flexible region of the tower, where the most severe damages were assessed (see Fig. 2). Observing the time-history responses in Fig. 16 and the results in Table 6 it is possible to notice how the amplitude of the response in the PR-I and PS-I configurations is quite similar with all the three aftershocks. As shown in Fig. 16, the response in the direction of the x and y reveals quite similar results between PR-I and PS-I differing only by the time of occurrence of the peak displacement. Only the responses to AS1 and AS3 aftershocks show an improvement of global behaviour when considering the maximum response in terms of displacement.
